Fixing Boots' damp floors

High street pharmacy chain, Boots' Elgin store had flooded twice in one year. The flooring was hazardous, unsightly and sat above 90% RH as a result. Luckily, IOBAC was on hand to help.

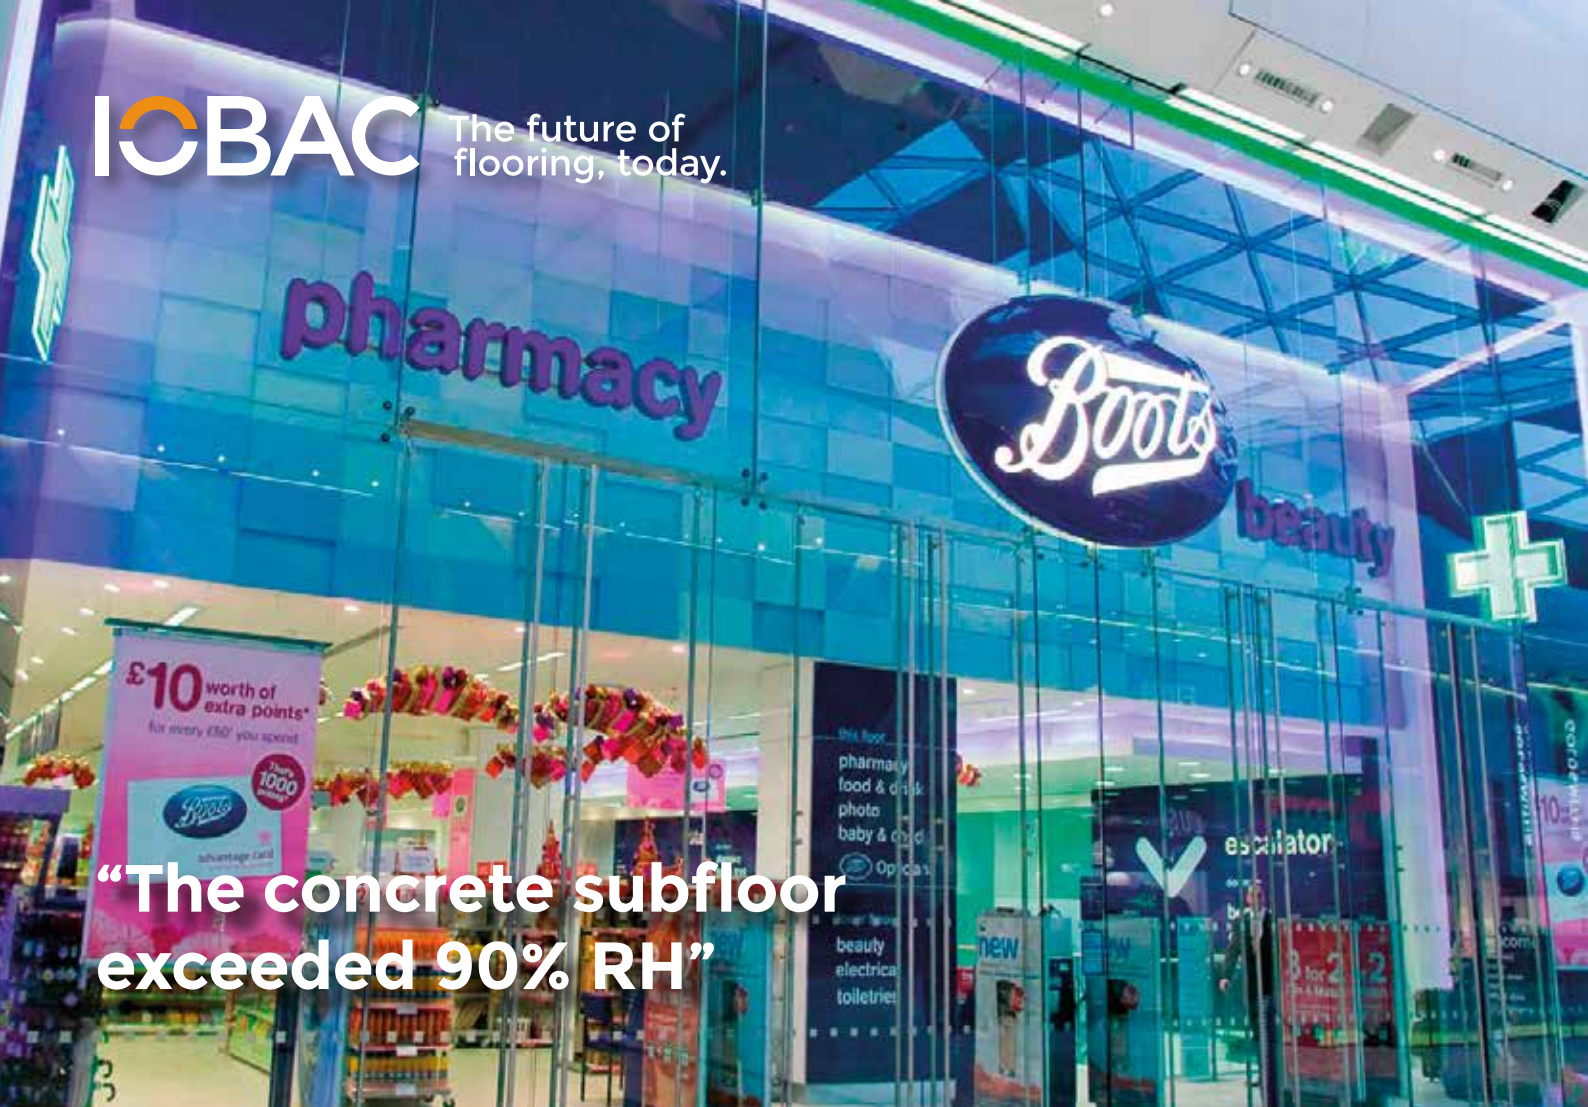
“The concrete subfloor exceeded 90% RH”

The flooring throughout the store had been extensively patch repaired and areas of the existing floor had failed due to the ingress of water. The smoothing compound had cracked; the vinyl was lifting and curling, creating dangerous trip hazards to both customers and staff.

Boots specified the IOBAC flooring system for this project. The 3M paramagnetic (metallised) resin dries in an hour, it is water permeable and able to withstand RH (Relative Humidity) levels up to 95% RH, obviating the requirement for a surface DPM (Damp Proof Membrane). The floor in the Elgin store exceeded 90% RH, by negating the need for a surface DPM this reduced installation time by a minimum of 80%. IOBAC is the only flooring system in the world that could mitigate the risk of future flooring failures, while the store remained open.

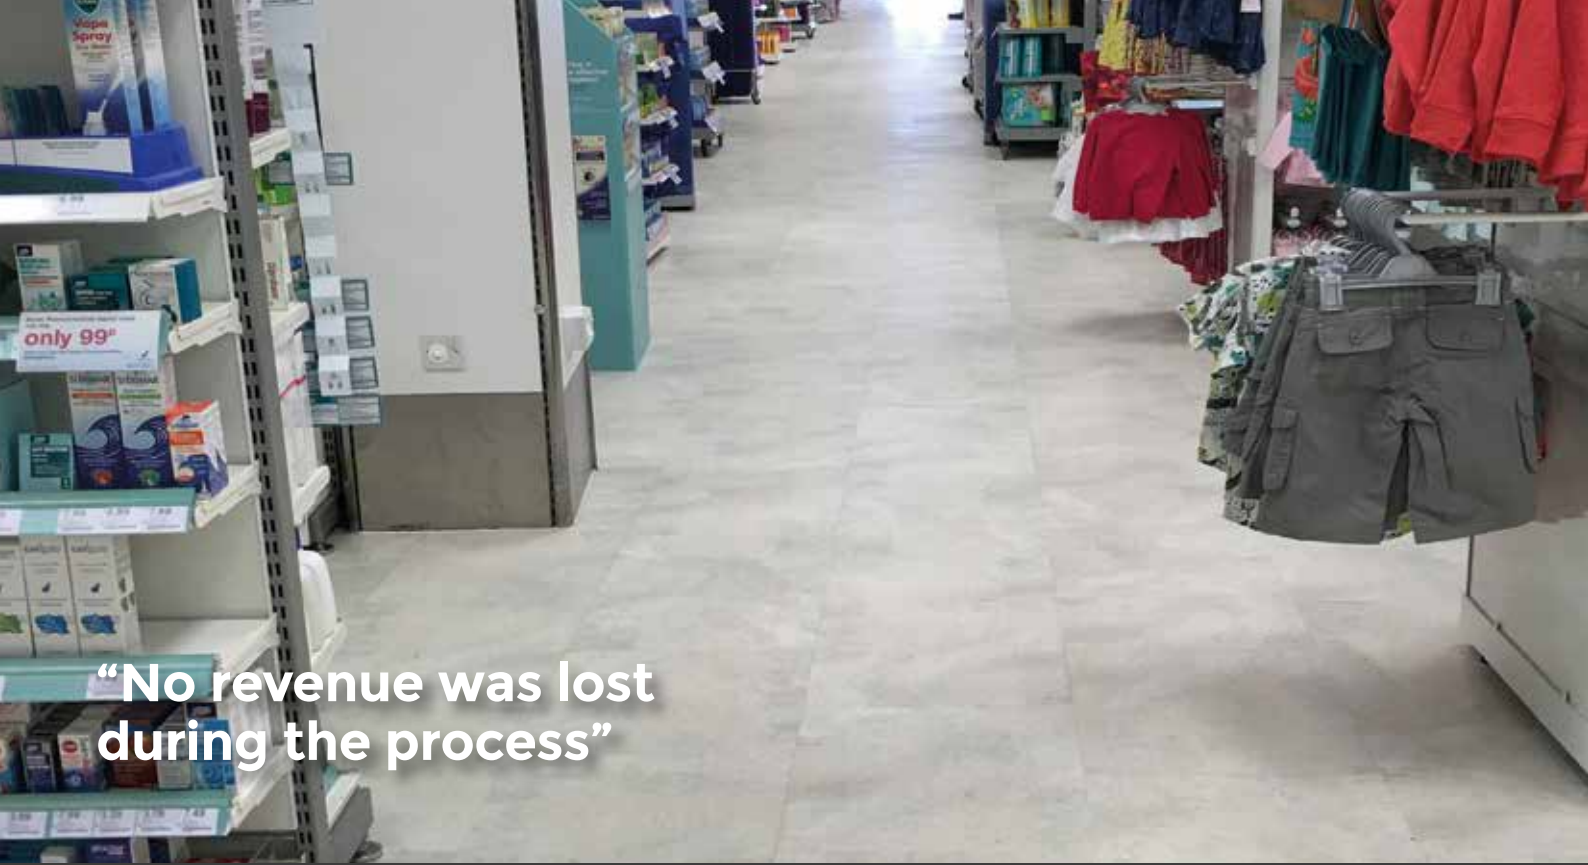
“No revenue was lost during the process”
